MILLSTONE, W.VA.
SE/4 ARNOLDSBURG 15 QUADRANGLE
N3845—WB100/7.5

LANDSLIDES AND RELATED FEATURES OF THE MILLSTONE, W.VA. QUADRANGLE

GREGORY C. OHLMACHER

OPEN FILE MAP 83-80 (G-8)

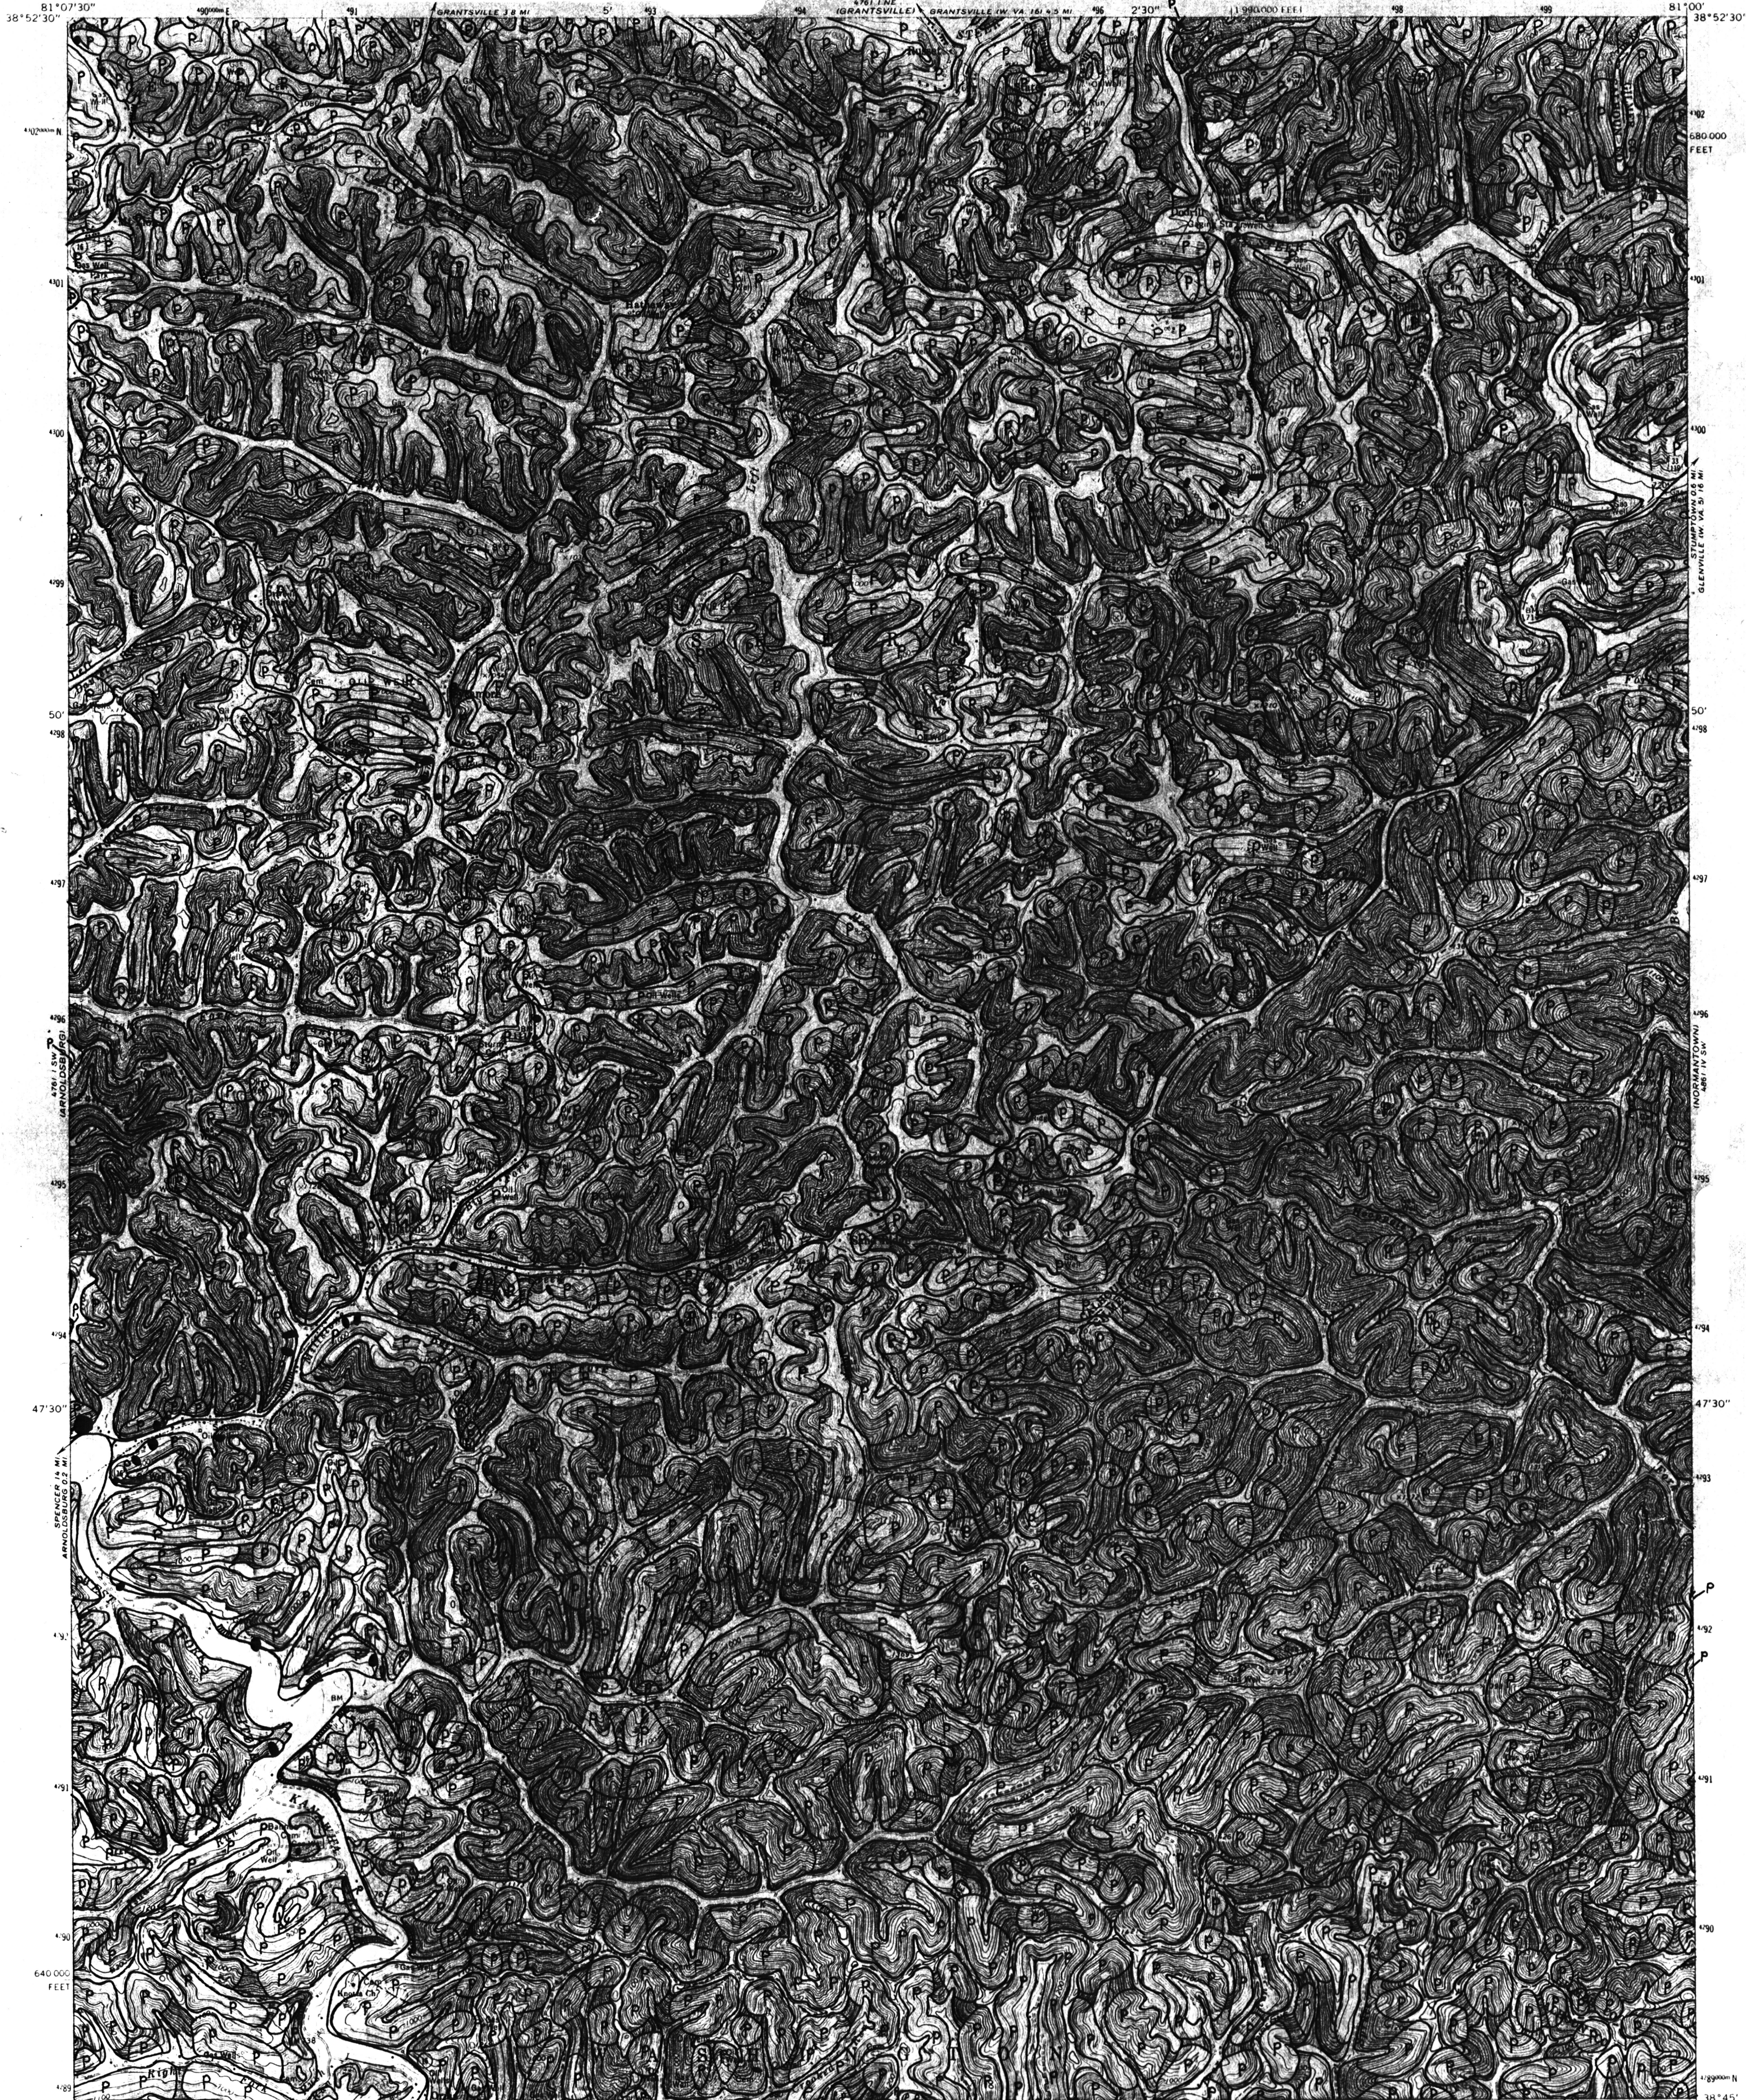
ACTIVE OR RECENTLY ACTIVE LANDSLIDE
Complex landslide composed of earthflow, debris
slide, earth and rock slump. Identified from
historical records, and from scars, debris and
other field evidence. Ground extremely unstable,
sliding accelerated by excavation, loading and
changes in drainage conditions. May include
areas with several active slides too small to
be shown separately.

OLD LANDSLIDE
Area of extensive hummocky ground caused by
earthflow and earth and rock slump. Lacks
clear evidence of active sliding. Relatively
stable in natural, undisturbed state,
generally not affected by small structures properly
sited in areas away from the edge of the toe,
can be reactivated by extensive, rapid exca-
vation, loading, and changes in ground water and
surface water conditions. Area of old landslide
probably includes recent ones not identified
from field evidence or otherwise documented.
Upslope boundary of landslide generally defined
by modified scarp, but downslope (toe) may be
gradational and not well defined.

COLLUVIAL SLOPE
Valley wall along major streams with slope as
steep as 40° (85%), stony, clayey silt soil up
to 50 ft. (15 m) thick; commonly buttressed by
a terrace or bench at the toe of the slope, very
susceptible to sliding by cutting of toe area,
removal of terrace or bench, and overloading,
slide commonly activated without apparent cause.

**AREAS SUSCEPTIBLE TO DEBRIS FLOWS AND DEBRIS
AVALANCHES**
Primarily shallow, narrow ravines and chutes with
accumulation of stony colluvium generally 10 ft.
(3 m) or less in thickness, susceptible to rapid
movement during intense rainfall. Most ravines
and chutes designated show evidence of former
debris flows and avalanches. Symbol-a design-
ates historical debris flow or debris avalanche.

AREAS SUSCEPTIBLE TO ROCKFALL
Steep, locally vertical, natural and man-made
slopes and cliffs, 15 ft. (4.5 m) or more high,
formed dominantly of sandstone, limestone, sandy
shale, mudstone and claystone. Interbedded mud-
stone, claystone and shale weather rapidly leaving
sandstone and limestone rock faces unsupported.

SOIL AND ROCK SUSCEPTIBLE TO LANDSLIDING
Soil and rock similar to that involved in land-
slides elsewhere in map area; primarily areas
underlain by claystone, mudstone and shale
associated with other rock types. Rock weathers
rapidly on exposure forming clayey soil highly
susceptible to sliding. Includes coves (U-shaped,
shallow valleys) containing thick layers of clayey
soil that are very susceptible to sliding where
excavation breaks continuity of slope and where
overloaded by artificial fill.

AREAS LEAST PRONE TO LANDSLIDES
Map areas in which no patterns or symbols are shown;
primarily valley floors, ridge tops and broad
benches; modification by excavation and fill may
lead to local landslides.
